Risk Assessment of an Existing  
School to the Effects from an  
LPG Vapor Cloud Explosion

Ray W. Anderson  
Agbabian Associates  
Pasadena, California

29 August 1990

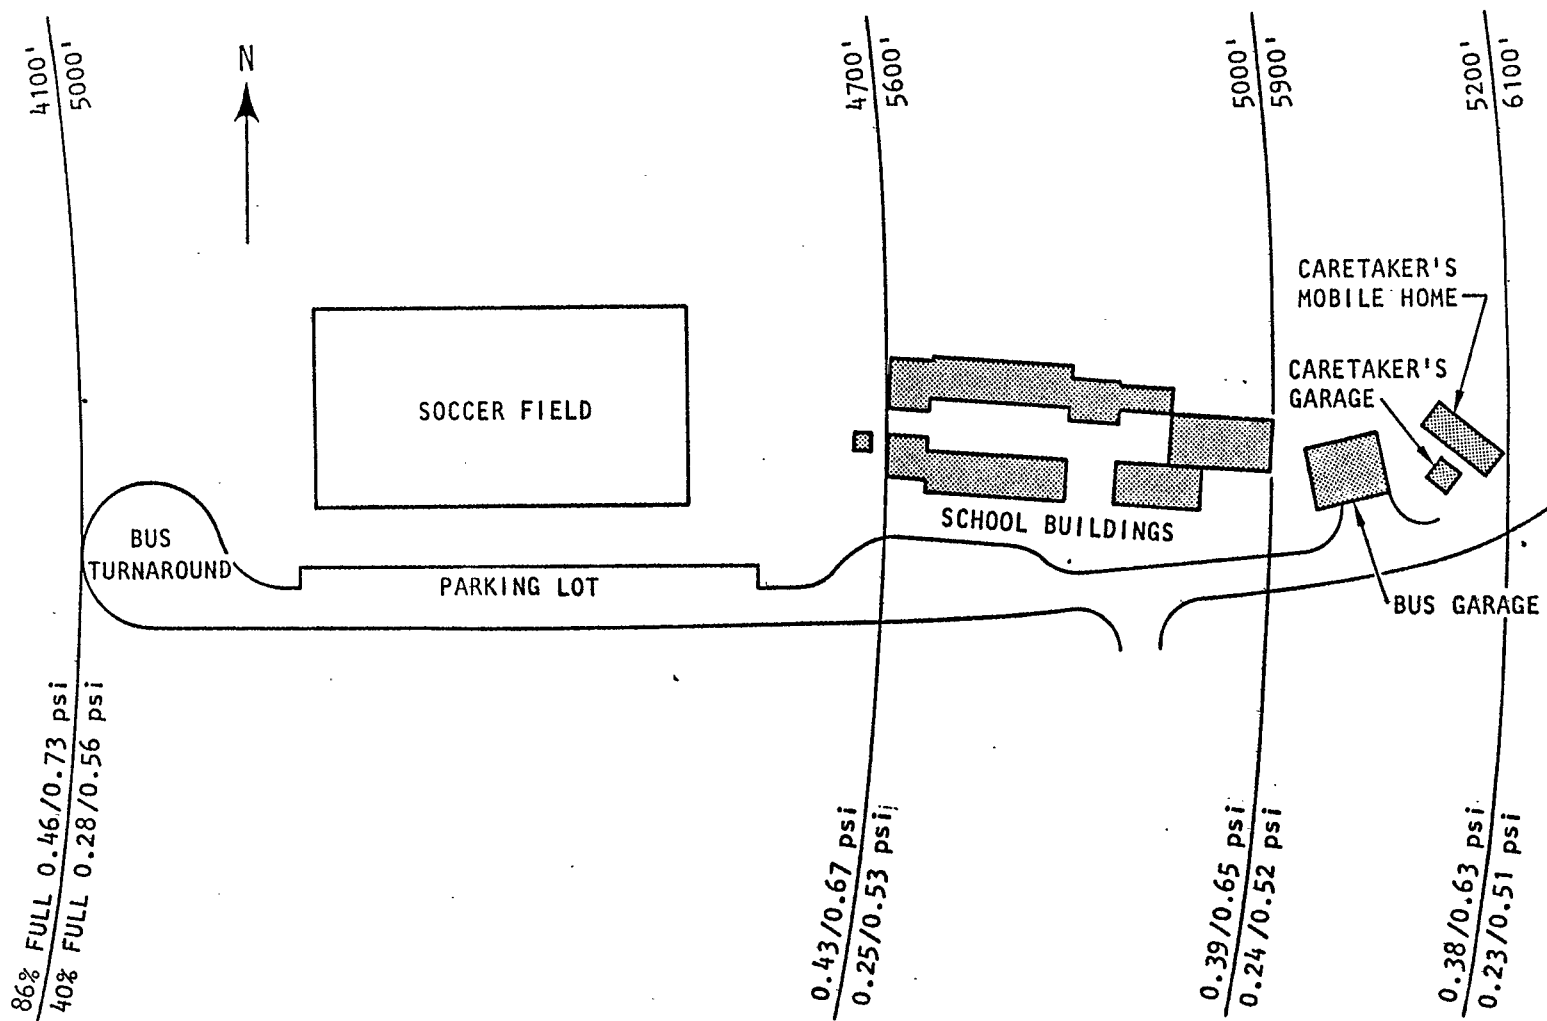
FIGURE 6. SMITH SITE OVERPRESSURE CONTOURS

Figure 6 shows contours of free-field overpressure on the Smith Site for the two vessel ullages defined in the previous paragraph and for two atmospheric conditions. The quoted distances are from the effective center of the explosion (point of ignition). The first overpressure quoted in each set has been calculated for a uniform, or standard, atmosphere. A uniform atmospheric condition is generally assumed when estimating the attenuation of airblast effects with distance. The second overpressure quoted in each set has been calculated for an enhancing atmosphere, which traps blast energy back to the ground, or bends blast energy back to the ground, or both. An invasion layer is the most common example of an enhancing atmosphere - such as the early morning coastal cloud and fog covers common for the school site. Estimates for overpressure for the enhancing atmosphere were made using the upper-bound enhancement factors that are typically used by the DoD to help manage the far-field effects of large explosions in remote areas. The estimates of overpressure for the standard atmosphere were taken from a DoE handbook (See Reference 3).

As shown in Figure 6, the overpressure is more-or-less constant over the site and equal to about 0.4/0.65 psi and 0.25/0.5 psi for the 86% and 40% - full vessel accidents, respectively. Also note that the overpressure difference between the two ullage conditions narrows for the enhancing atmosphere.

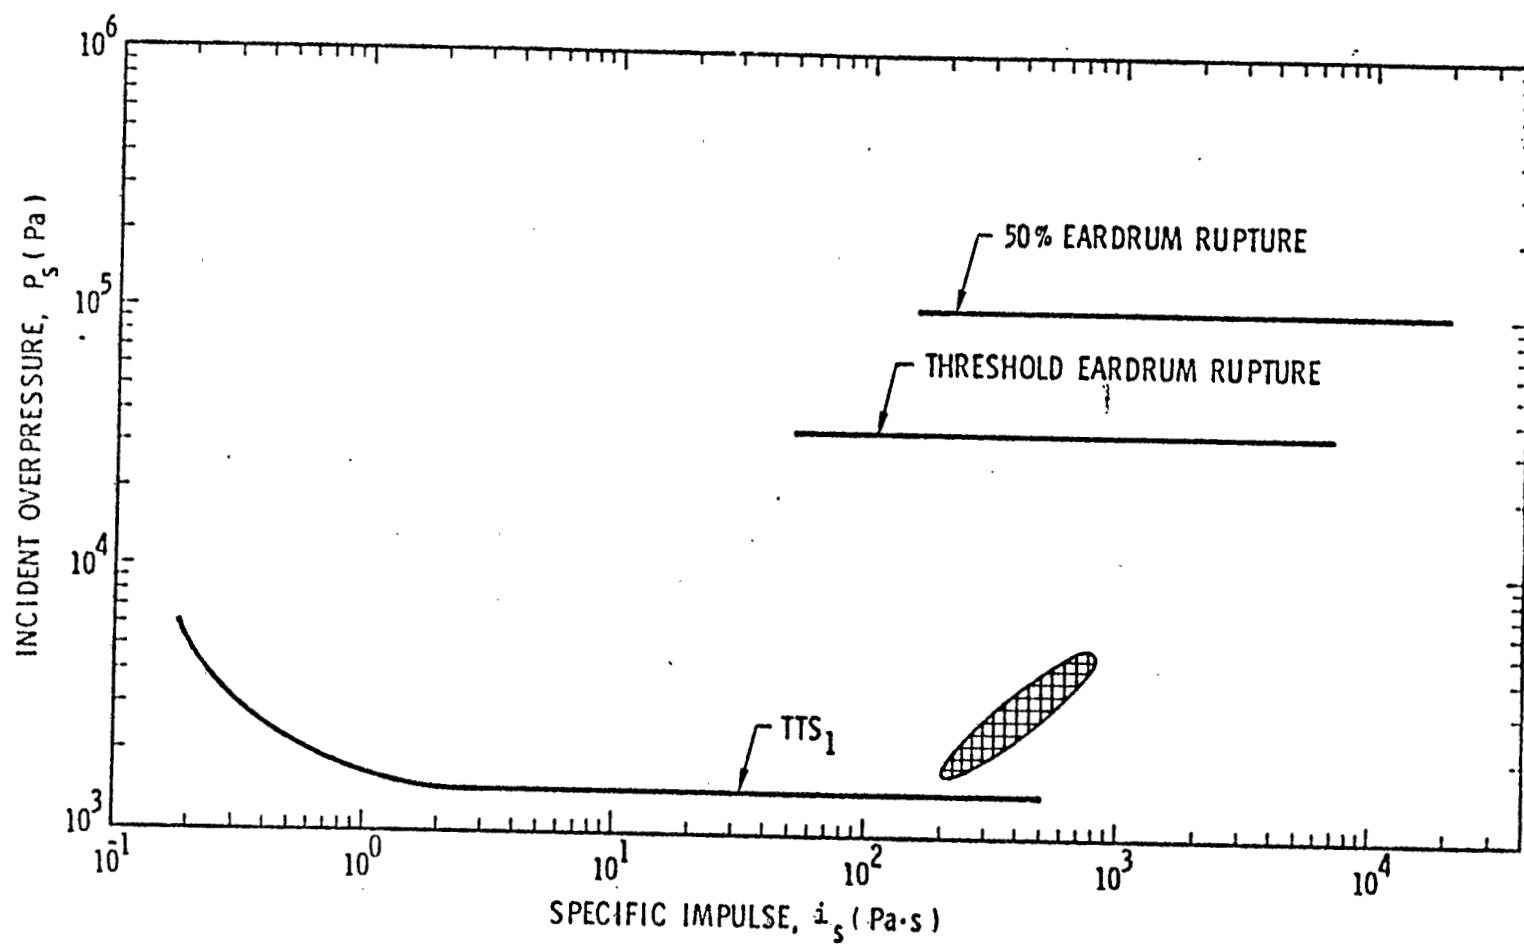
FIGURE 7. HUMAN EAR DAMAGE CURVES FOR BLAST WAVES  
ARRIVING AT NORMAL ANGLE ON INCIDENCE

Figure 7 shows the dependence of ear damage on the peak pressure and impulse of a fast-rising overpressure. The curve labeled TTS, is the threshold of a temporary loss of hearing. This loss, which is partial, would be reversed within a day or so. The full range of Smith Site overpressures are indicated on the figure as the cross-hatched area. It is seen that the Site overpressures are far too weak to rupture eardrums, but are strong enough to cause a temporary loss of hearing.

The TTS, asymptotic overpressure corresponds to a sound level intensity of about 155 db (By comparison, artillery fire is about 145 db). Since typical building construction attenuates sound levels by at least 20 db, those persons inside the school building and caretaker's trailer will not experience a temporary loss of hearing, provided the doors and windows are closed.

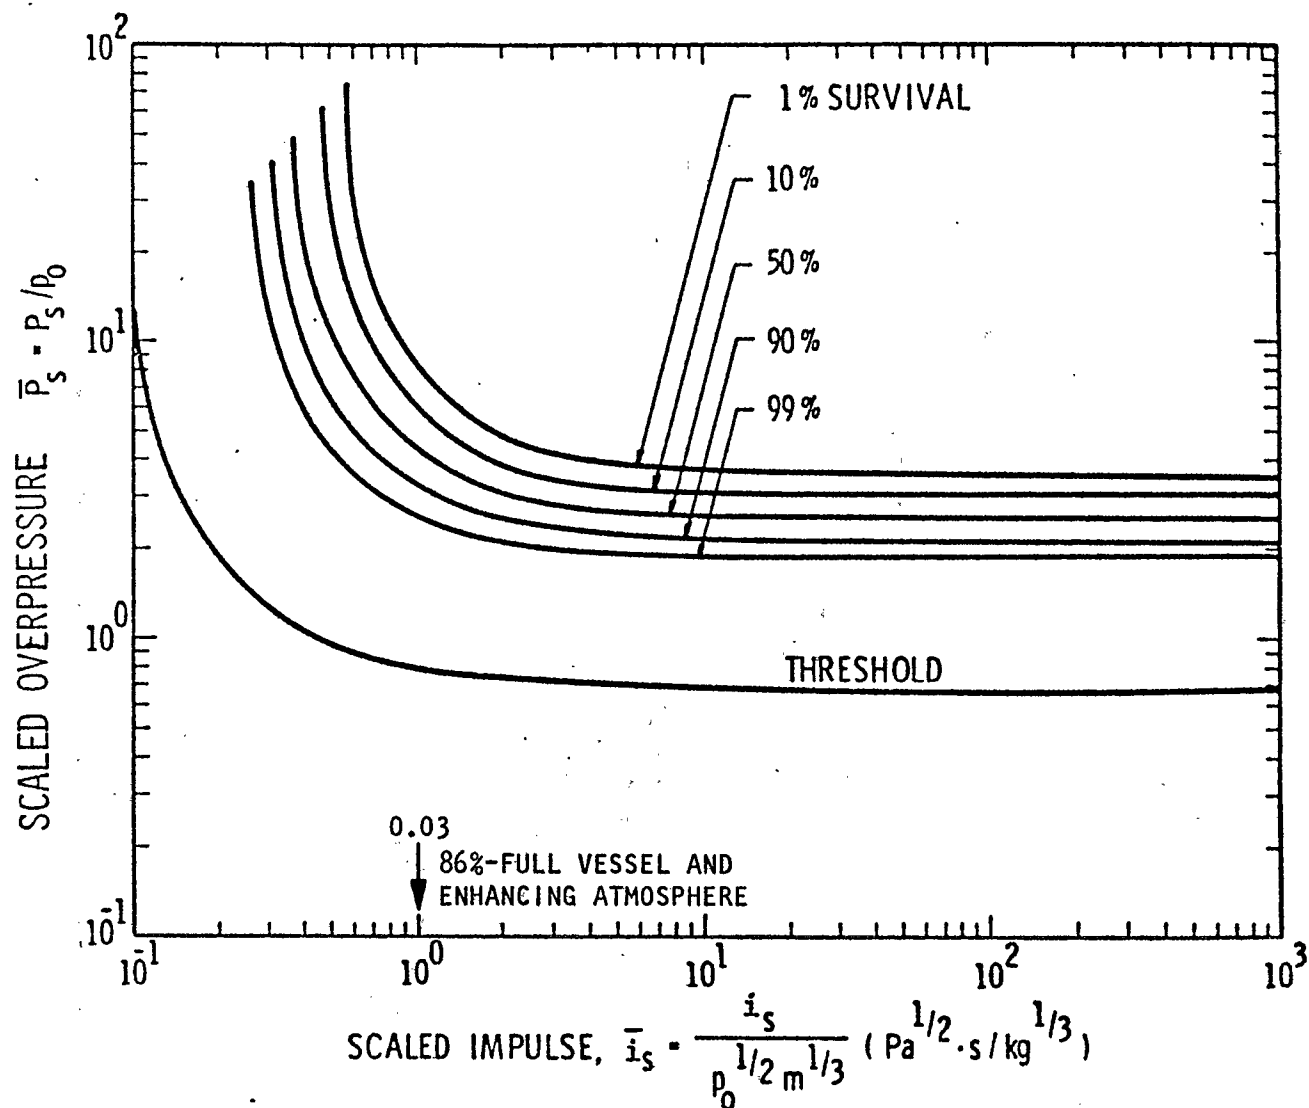
FIGURE 8. SURVIVAL CURVES FOR LUNG DAMAGE TO MAN

Figure 8 shows lung damage as a function of the peak pressure divided by ambient atmospheric pressure and the impulse of a fast-rising overpressure. The impulse is seen to be divided by the square root of the ambient atmospheric pressure ( $p_0$ ) and the cube root of the mass of the person ( $m$ ). The arrow indicates where the interaction of the Smith Site worst-case overpressure and an infant ( $m = 3$  kg) falls (off the plot). Clearly, there will be no lung damage on the Smith Site school grounds.

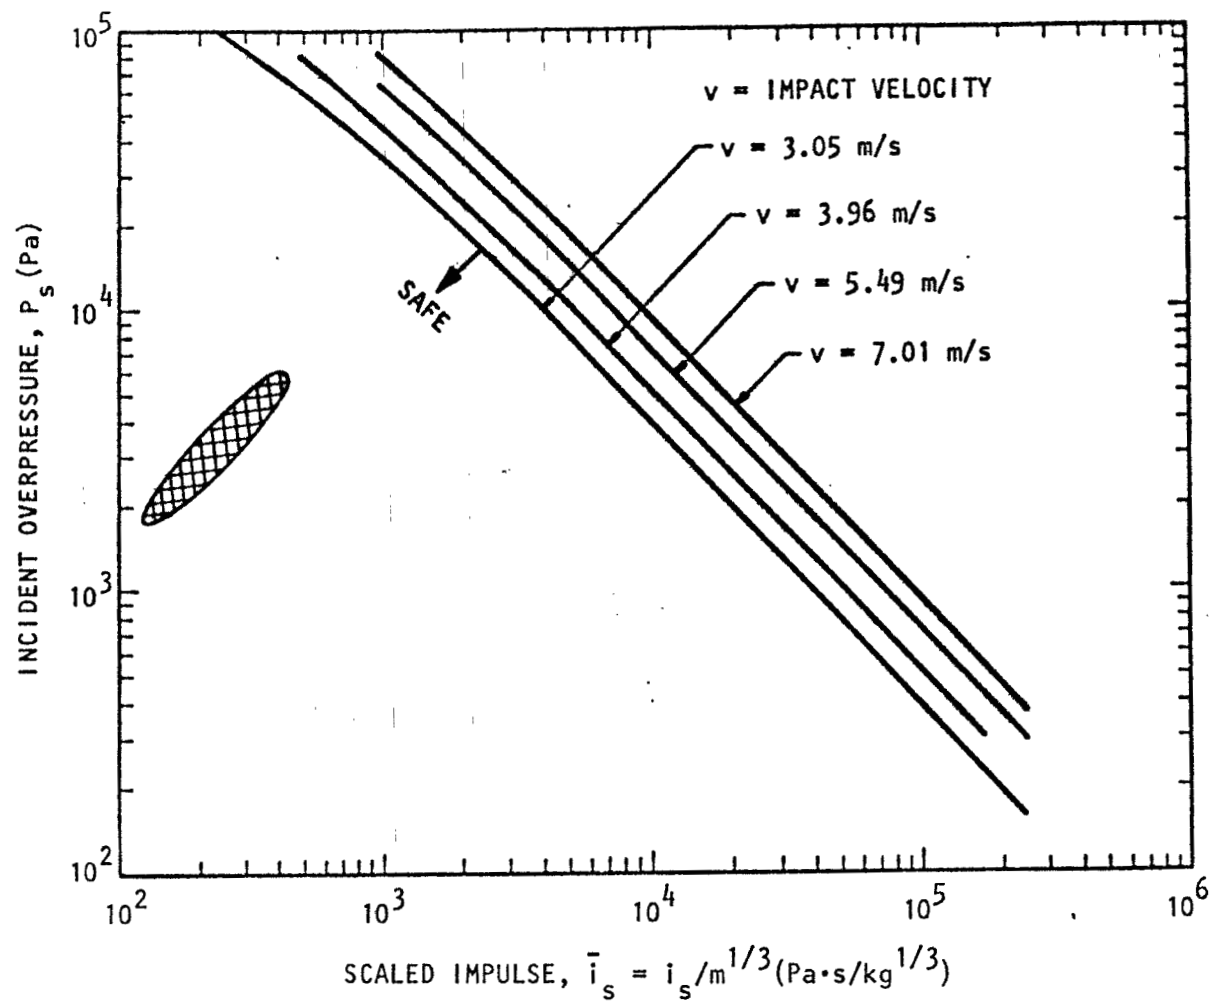
FIGURE 9. SKULL FRACTURE

The above data have been used to construct Figure 9. The figure indicates tolerance levels for skull fracture plotted against the peak pressure and impulse of the overpressure. The impulse is divided by the cube root of the mass of the person ( $m$ ). The lighter the body, the higher the attained velocity and the more likely skull fracture. The full range of the Smith Site overpressure acting on a toddler ( $m=10$ kg) is indicated by the cross-hatched oval. It is seen that the Smith Site airblast is far too weak to cause skull fracture. This same conclusion also applies for whole-body impact. The maximum blast-induced velocity

that a person attains on the Smith Site school grounds is less than about 2 fps.

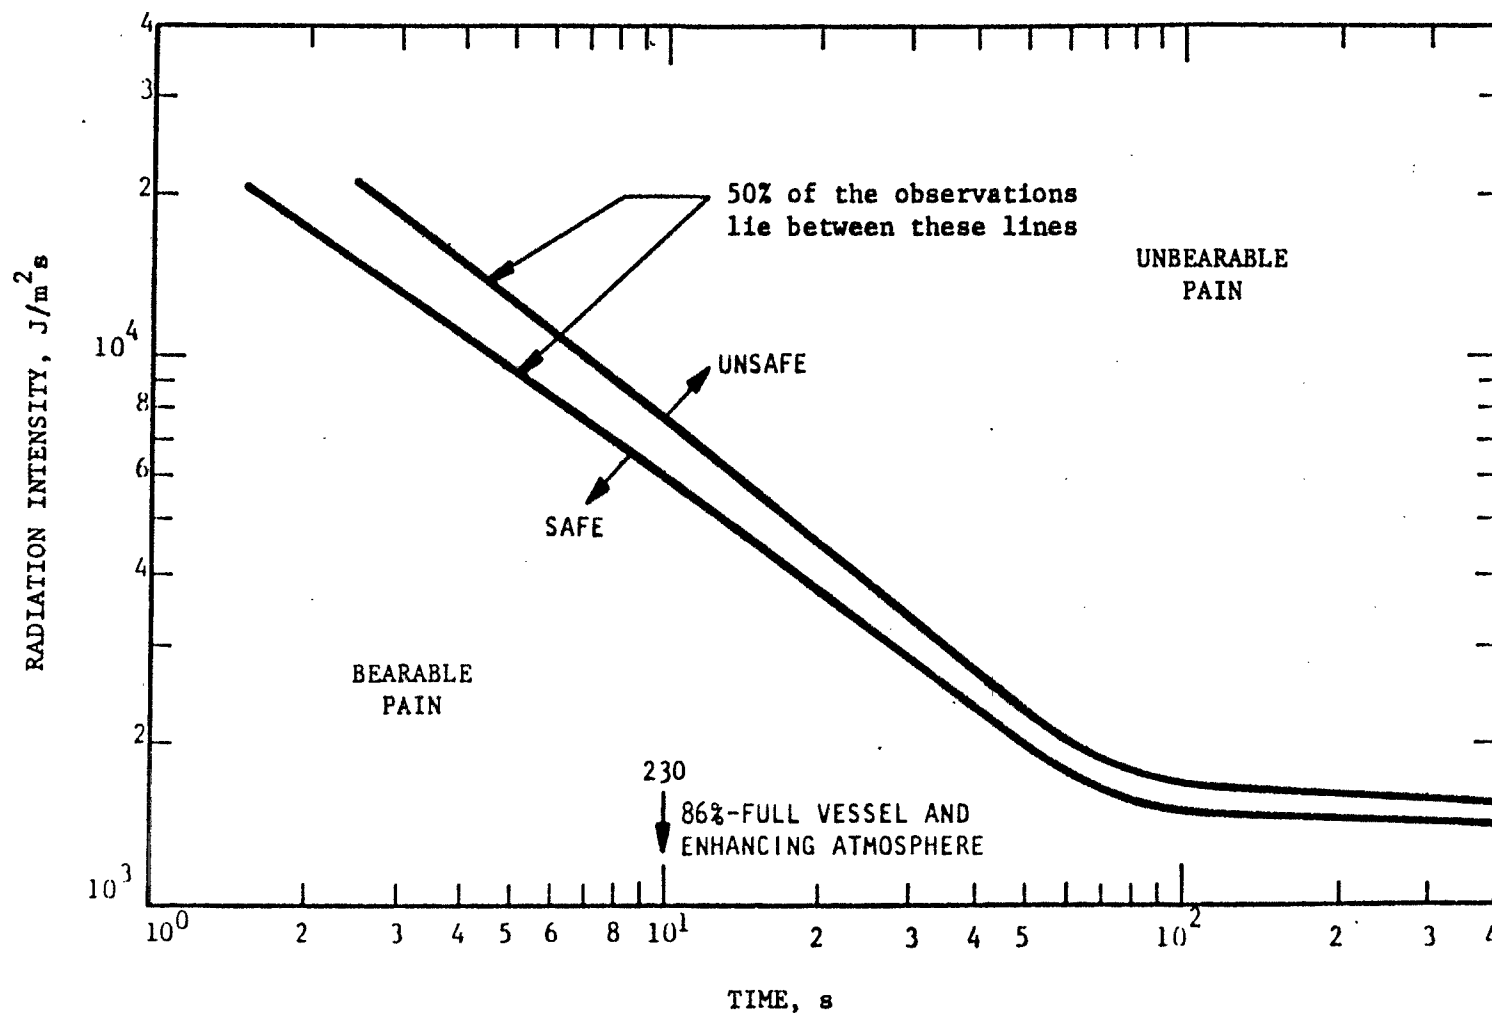
FIGURE 10. THRESHOLD OF PAIN FROM THERMAL RADIATION ON BARE SKIN

Figure 10 shows how much and how fast thermal radiation must be delivered to human skin to cause unbearable pain, i.e., to burn. It is seen from the figure that the thermal radiation falling on the Smith Site school grounds for the 86%-full vessel accident and enhancing atmosphere is so low that it falls off the plot.

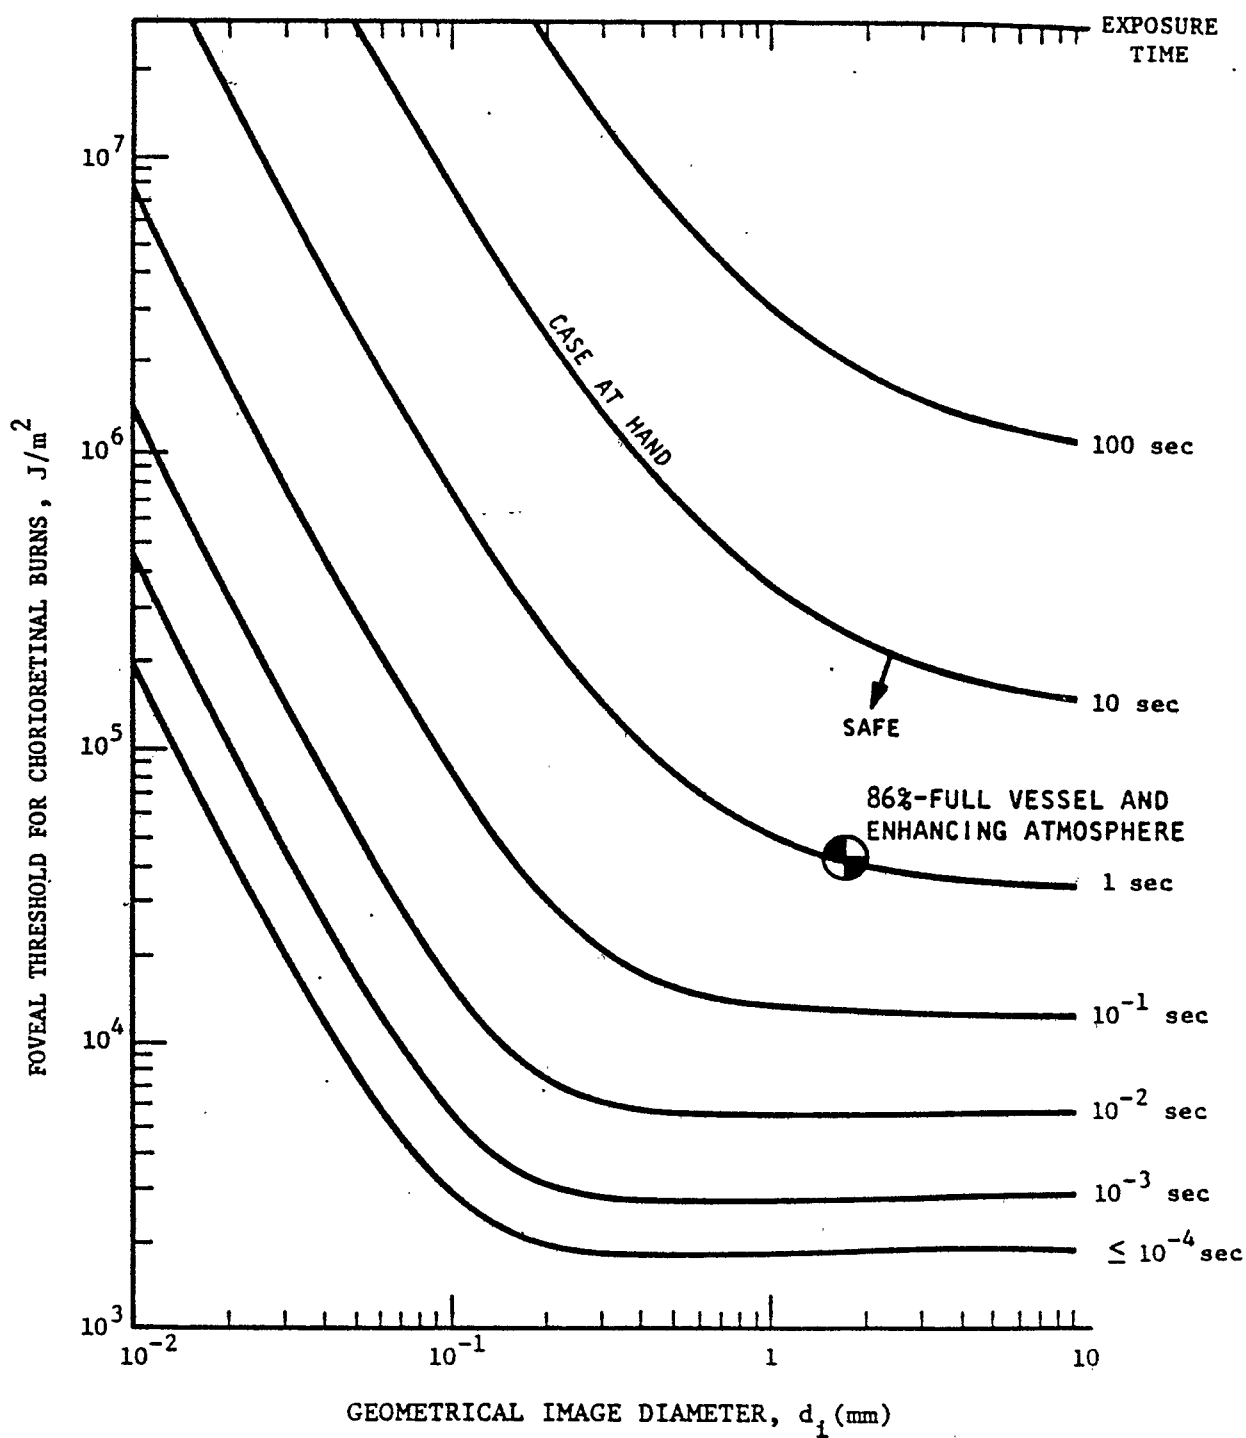
FIGURE 11. CHORIORETINAL BURN THRESHOLDS FOR PRIMATES

As shown in Figure 11, the thermal radiation delivered to the Smith Site school ground is too low to cause chorioretinal damage, even to the indicated wide-eyed observer of the entire fireball burn. For an explanation of the derivations of geometrical image diameter and Foveal threshold for chorioretinal burns, Reference 4 should be consulted.

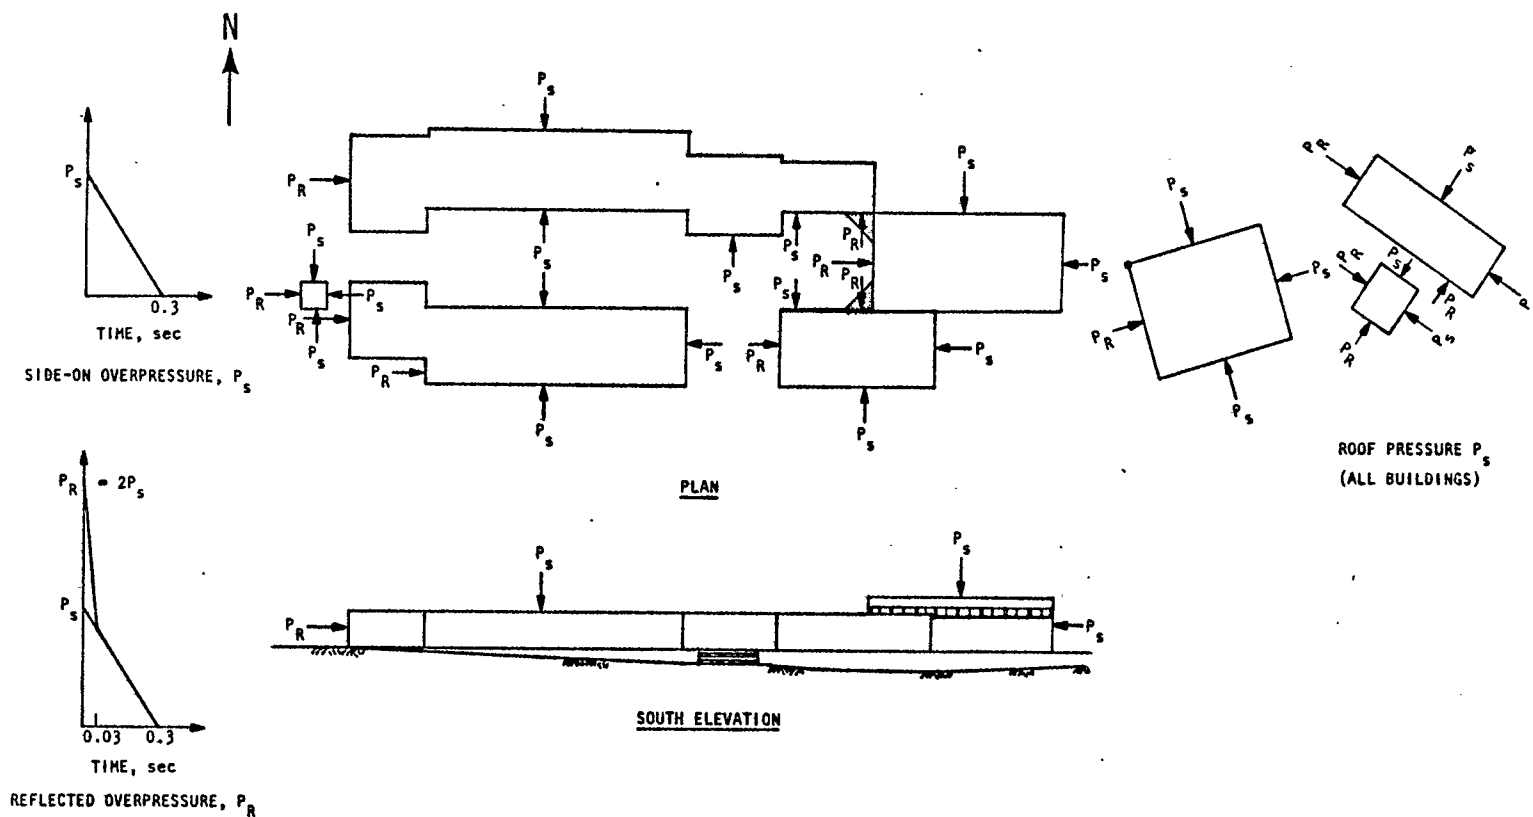
FIGURE 12. AIRBLAST LOADINGS ON SCHOOL AND ANCILLARY BUILDINGS

The airblast loads that act on the exterior surfaces of the various buildings are shown in Figure 12, where the typical values of  $P_g$  indicated by the overpressure contours indicated in Figure 6 are applicable. Note that the duration of the load has been standardized at 0.3 sec. The school building is optimally oriented, in that only one door and a few windows see a reflected pressure. Only the west-facing walls of the school building see a reflected overpressure.
